DEPARTMENT OF TRANSPORTATION

Contract #: 04-0120F4Cty: SF/ALA Rte: 80 PM: 13.2/13.9File #: 99.28**WELDING INSPECTION REPORT****Resident Engineer:** Siegenthaler, Peter**Address:** 333 Burma Road**City:** Oakland, CA 94607**Report No:** WIR-018169**Date Inspected:** 17-Nov-2010**Project Name:** SAS Superstructure**OSM Arrival Time:** 700**Prime Contractor:** American Bridge/Fluor Enterprises, a JV**OSM Departure Time:** 1900**Contractor:** Zhenhua Port Machinery Company, Ltd (ZPMC)**Location:** Shanghai, China

Orthotropic Box Girder (OBG) at Trial Assembly Areas

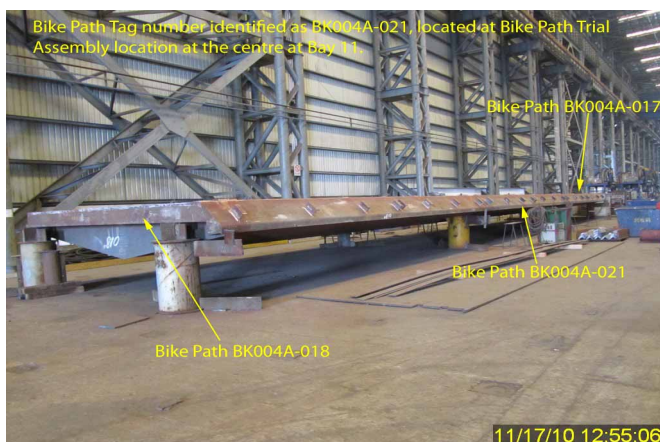
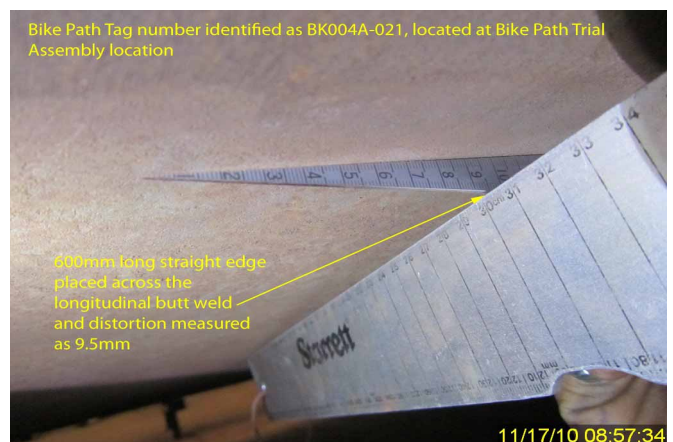
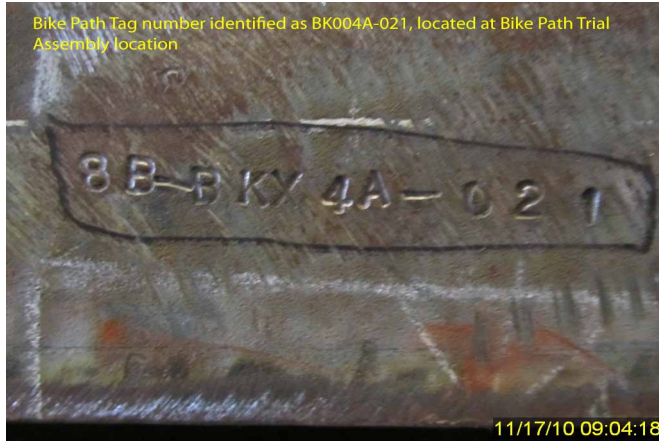
The QA Inspector measured the flatness using 600mm long straight edge and observed flatness dimensions out of allowable tolerance.

Please reference the pictures attached for more comprehensive details.
